SUBJECT: Results of Year 6 Operations, Maintenance, and Monitoring Plan Site Activities; Head of the Thea Foss Waterway Remediation, Tacoma, WA

Date: June 3, 2010
To: Jacqueline Thiell Wetzsteon, PacifiCorp
From: Benjamin Starr *Benjamin I. Starr* and Gary Braun *Gary Braun*
RE: Low Tide Site Observations and Maintenance
April 19, 2010
Head of the Thea Foss Waterway Project

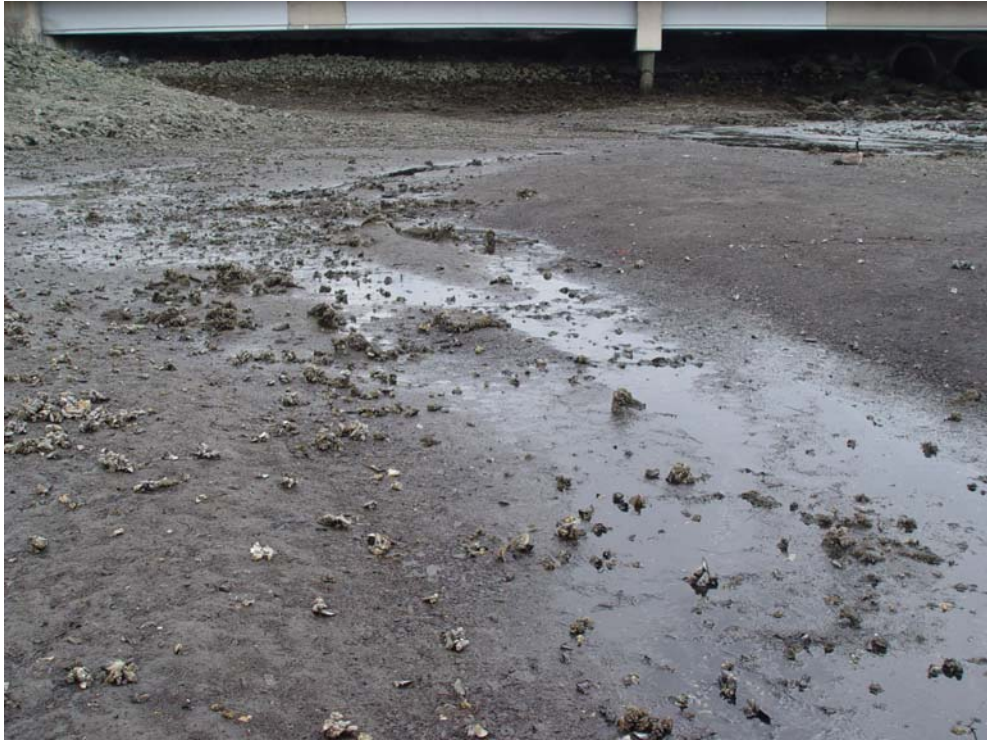
Figure 9 – Looking south across the narrow channel near SE corner of the waterway

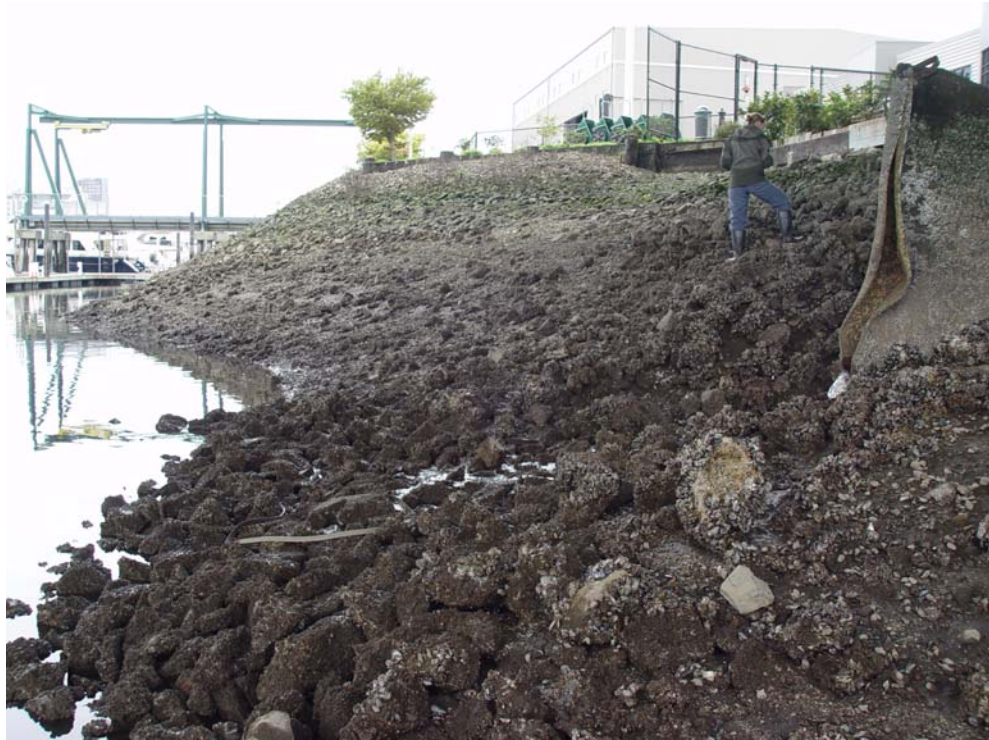
Figure 11 – Looking north at the east slope of the waterway from under the SR-509 Bridge (duckbill on Outfall #243 visible at right)

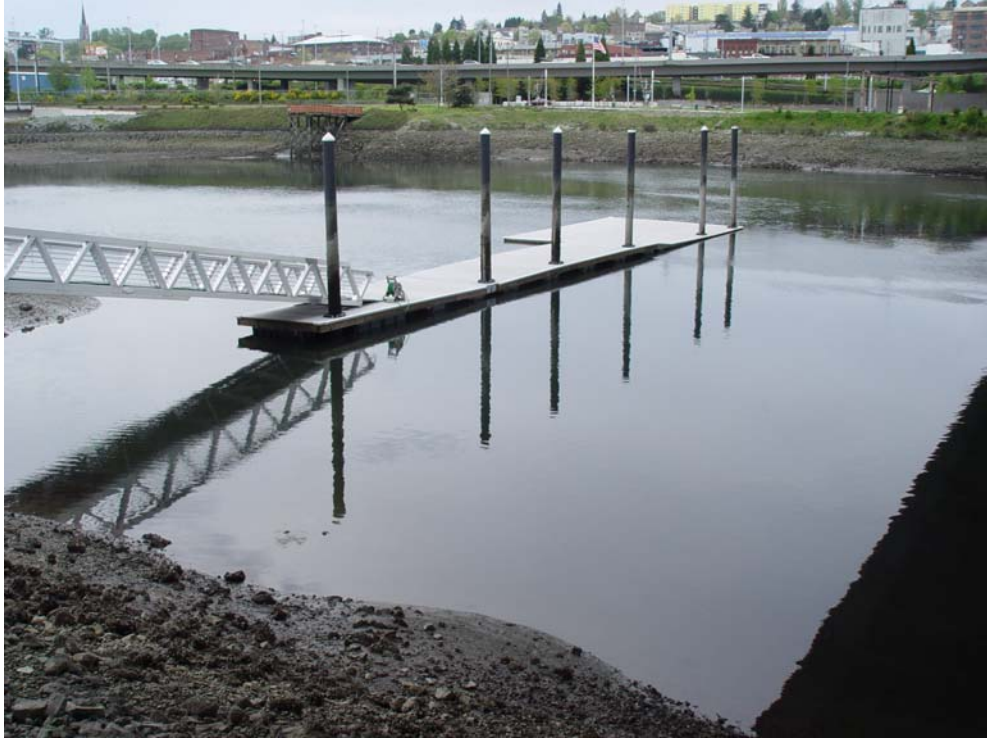
- The new kayak float on the east side of the Waterway just south of the SR-509 Bridge is in use. One recreational kayaker was observed using the facility when Katrina Conlon arrived onsite.

Figure 13 – Looking west at recently installed kayak dock
